## ML Utilities USED VEHICLE CONDITION REPORT

CHASSIS INFO: 6.	1) and 1	Q.	Date Inspected: 9 25 2	1.1		
Vehicle Number: NS711602						
Work Order: NS 11602			Madal Vasa	12500Hi		
			2011			
, DECTA	LTEET	SERVICE IN		CF12324		
Current Mileage: 219	435		Current Engine Hours:			
Total Repair Estimate			Inspector: J. DETZOFF	Inspector: J. DETZOFF		
		Equipment- select all th	at apply			
Body			Rail Gear	B		
Compressor			Welder			
Crane			Digger Derrick			
Bucket			Other			
Equipment Location:	П		Chattanooga (CTE Cummings)			
Chattanooga (CTE Gifford)			Mableton (CTE)			
Spring Hills (UES)	t <del></del>		Baltimore (MLUFS)			
Charlotte (MLUFS)			Other Address(enter address)

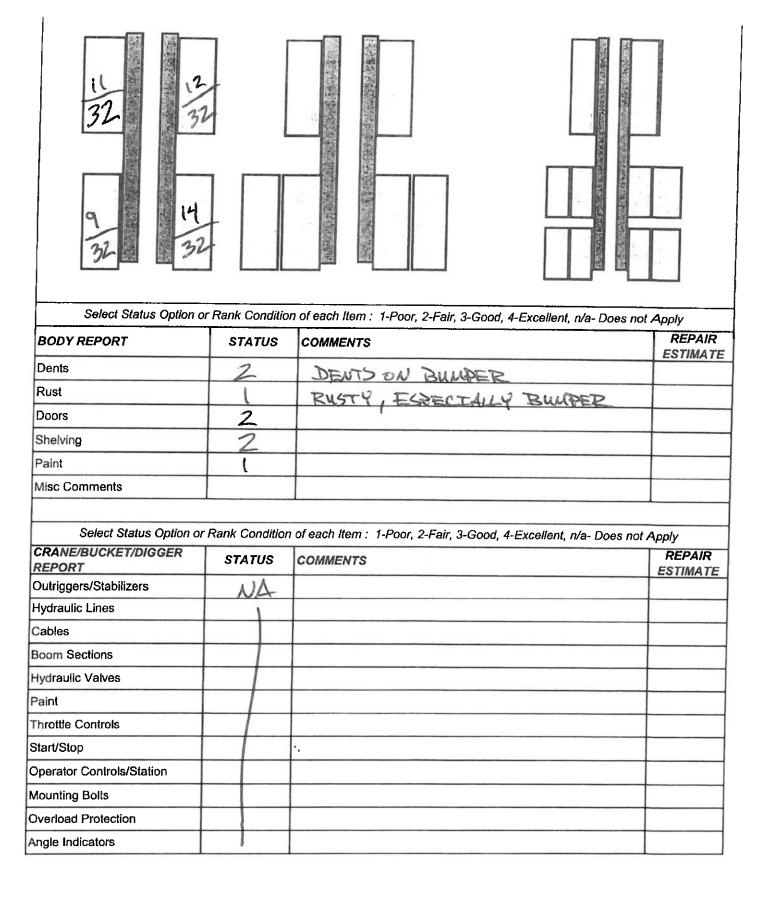
Other Mechanical(list each item — FRONT PASS. W DRIVERS SWI	INDOW SI	WEEKING WOT	PKS AT DOOR		
ire Comments/Overall Condition	on		L		
lisa	the helow drawing	to fill out the Tire Tread dept	h for each tire in 32nds
